LA JOLLA CHILDREN'S POOL

BEACH MANAGEMENT AND WATER QUALITY IMPROVEMENT PROJECT

CE Ref No. 98-9

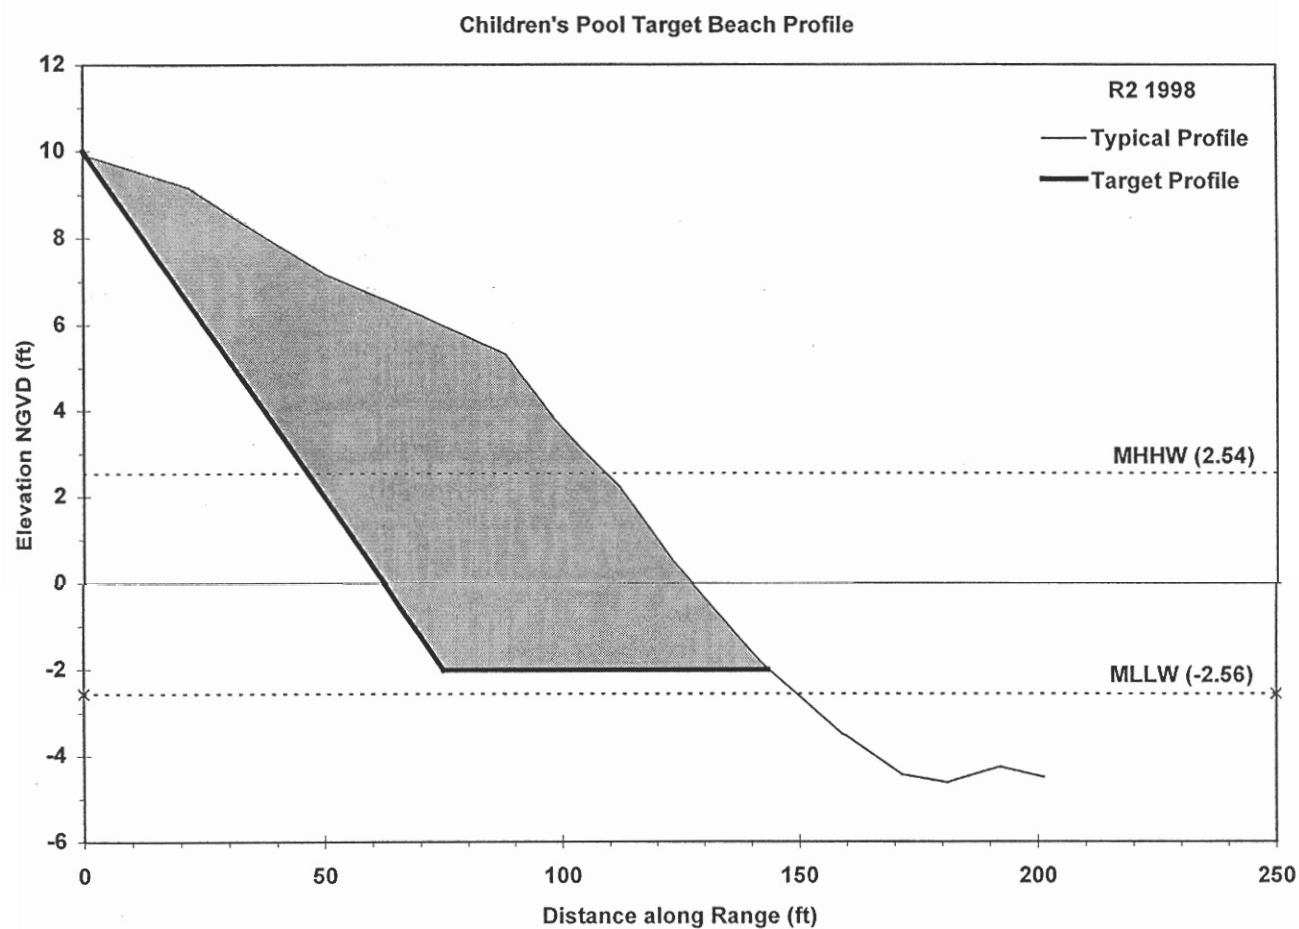
Figure 8. Beach profile configuration before and after dredging.

The proposed project will consist of removing up to 3,000 yd³ of beach sand. Figure 8 shows the existing beach profile and the proposed profile after excavation. About 720 ft³ of sand will be removed per foot of beach. After completing the excavation, the beach profile will be slowly adjusted such that it will be deeper at the outer side and narrower at the landward side, providing children with space to swim. The project will be conducted in the off-season, between October 1st and Memorial Day weekend. A monitoring period will follow these steps to assess the effectiveness of the sand removal in fulfilling the objectives of the project. The sand characteristics in the pool are described below, followed by a discussion of proposed excavation, transport, and disposal options and methods.

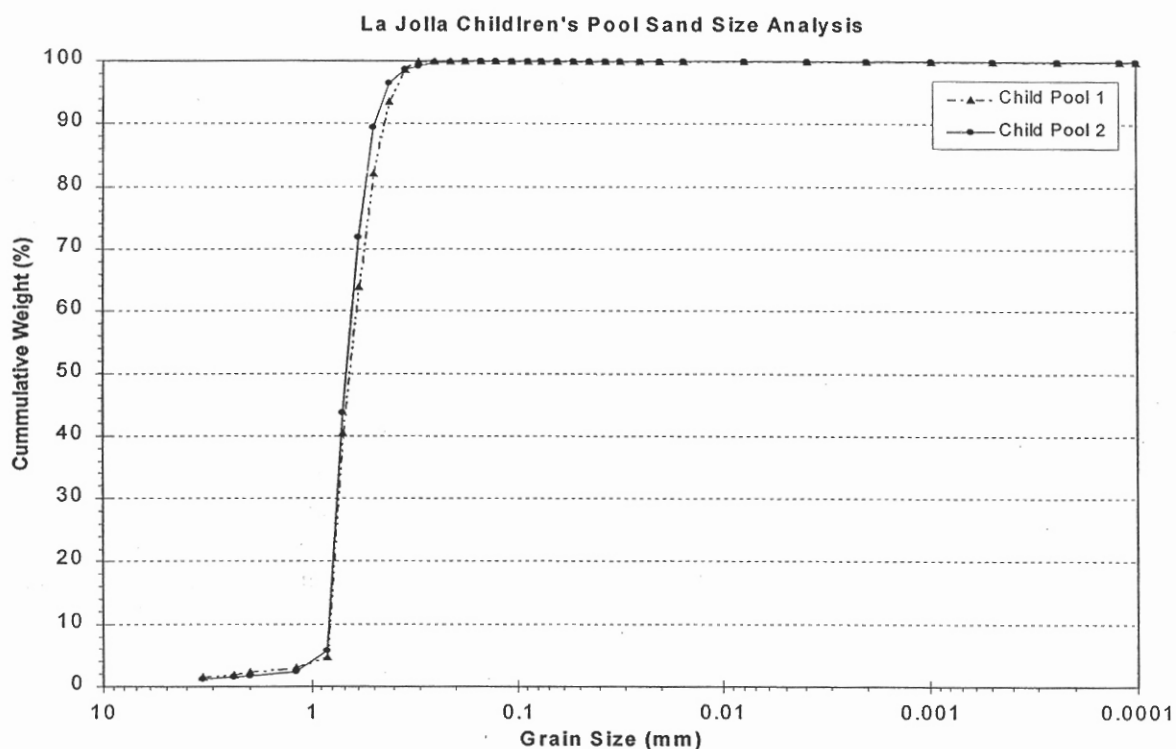
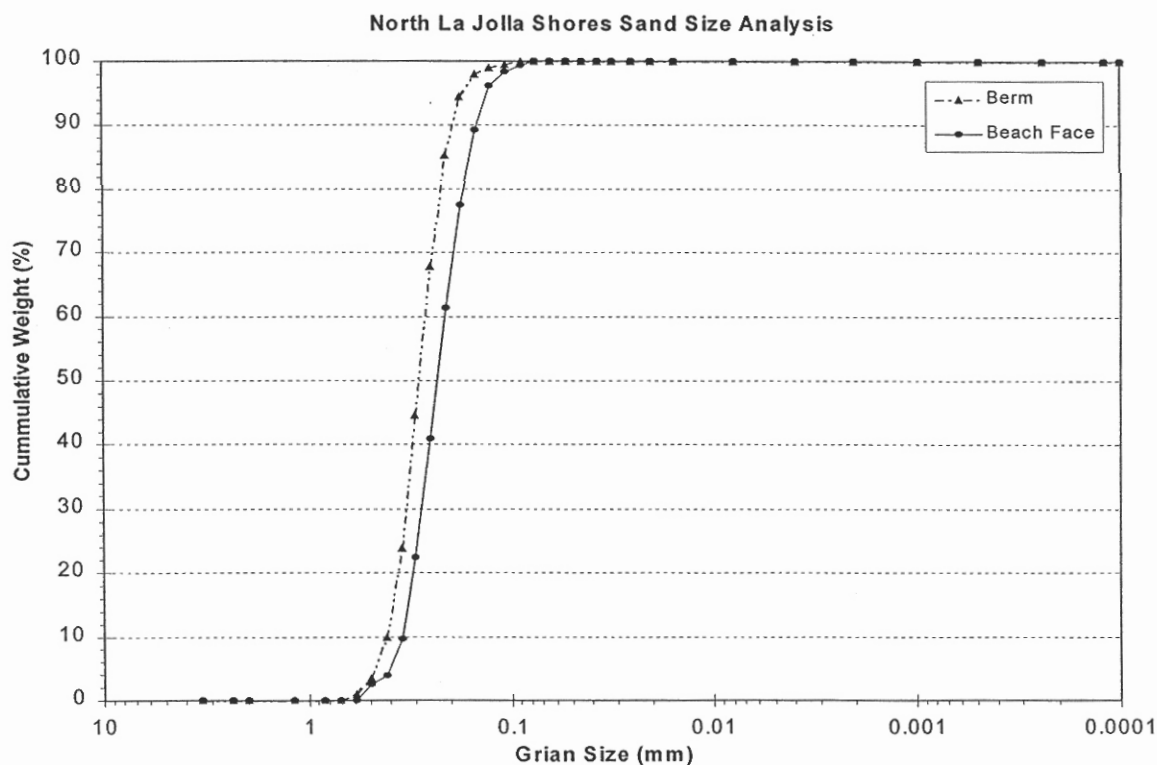
Figure 9. Cumulative grain-size distribution for sand samples from the Children's Pool and North La Jolla Shores.

The sand in the Children's Pool has a median grain size of greater than 0.660 mm. This is somewhat coarser than the sand found on La Jolla Shores Beach, which has a median grain size of about 0.230 mm. The cumulative grain-size distribution for four samples collected in August 1998 from La Jolla Children's Pool and from north La Jolla Shores are shown in Figure 9.

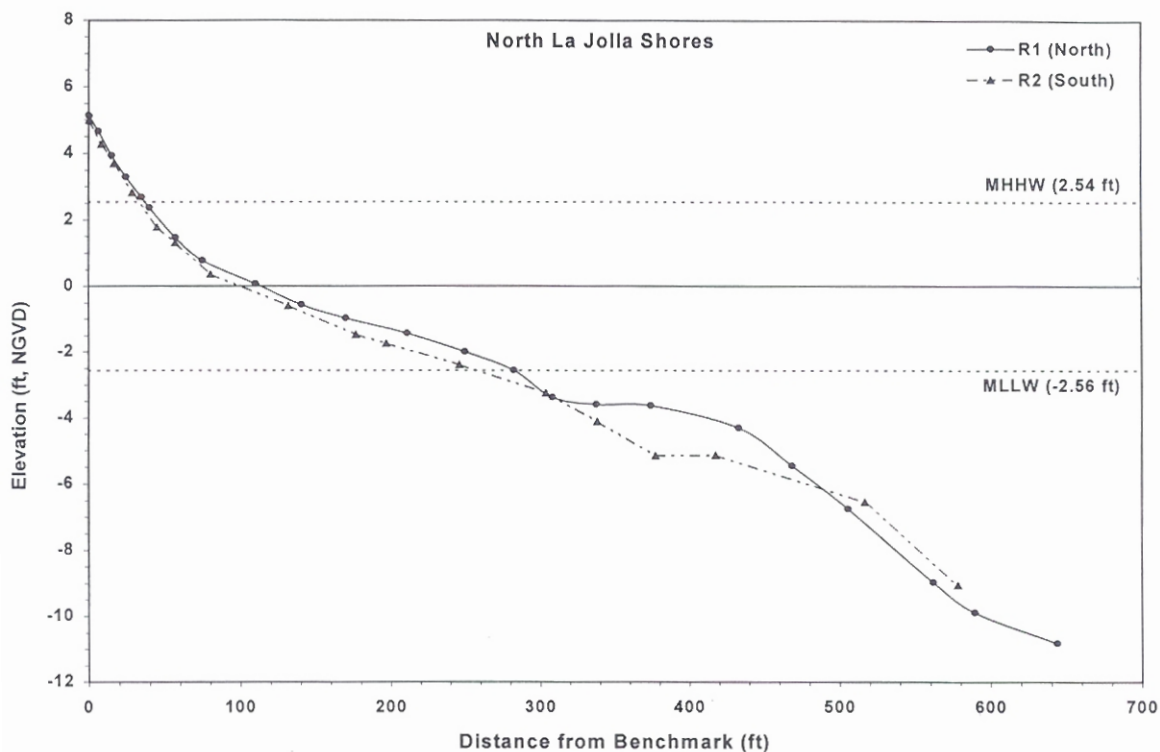
Figure 12. Beach profiles of north La Jolla Shores disposal site.

A beach-profile survey was made at north La Jolla Shores on 23 August 1998 at two locations within the disposal area. Figure 12 shows the beach profile at R1 and R2 and Figure 13 is a photograph taken on August 17, 1998 of the disposal site. This photograph shows the lack of beach access at this stretch of beach during high tides.

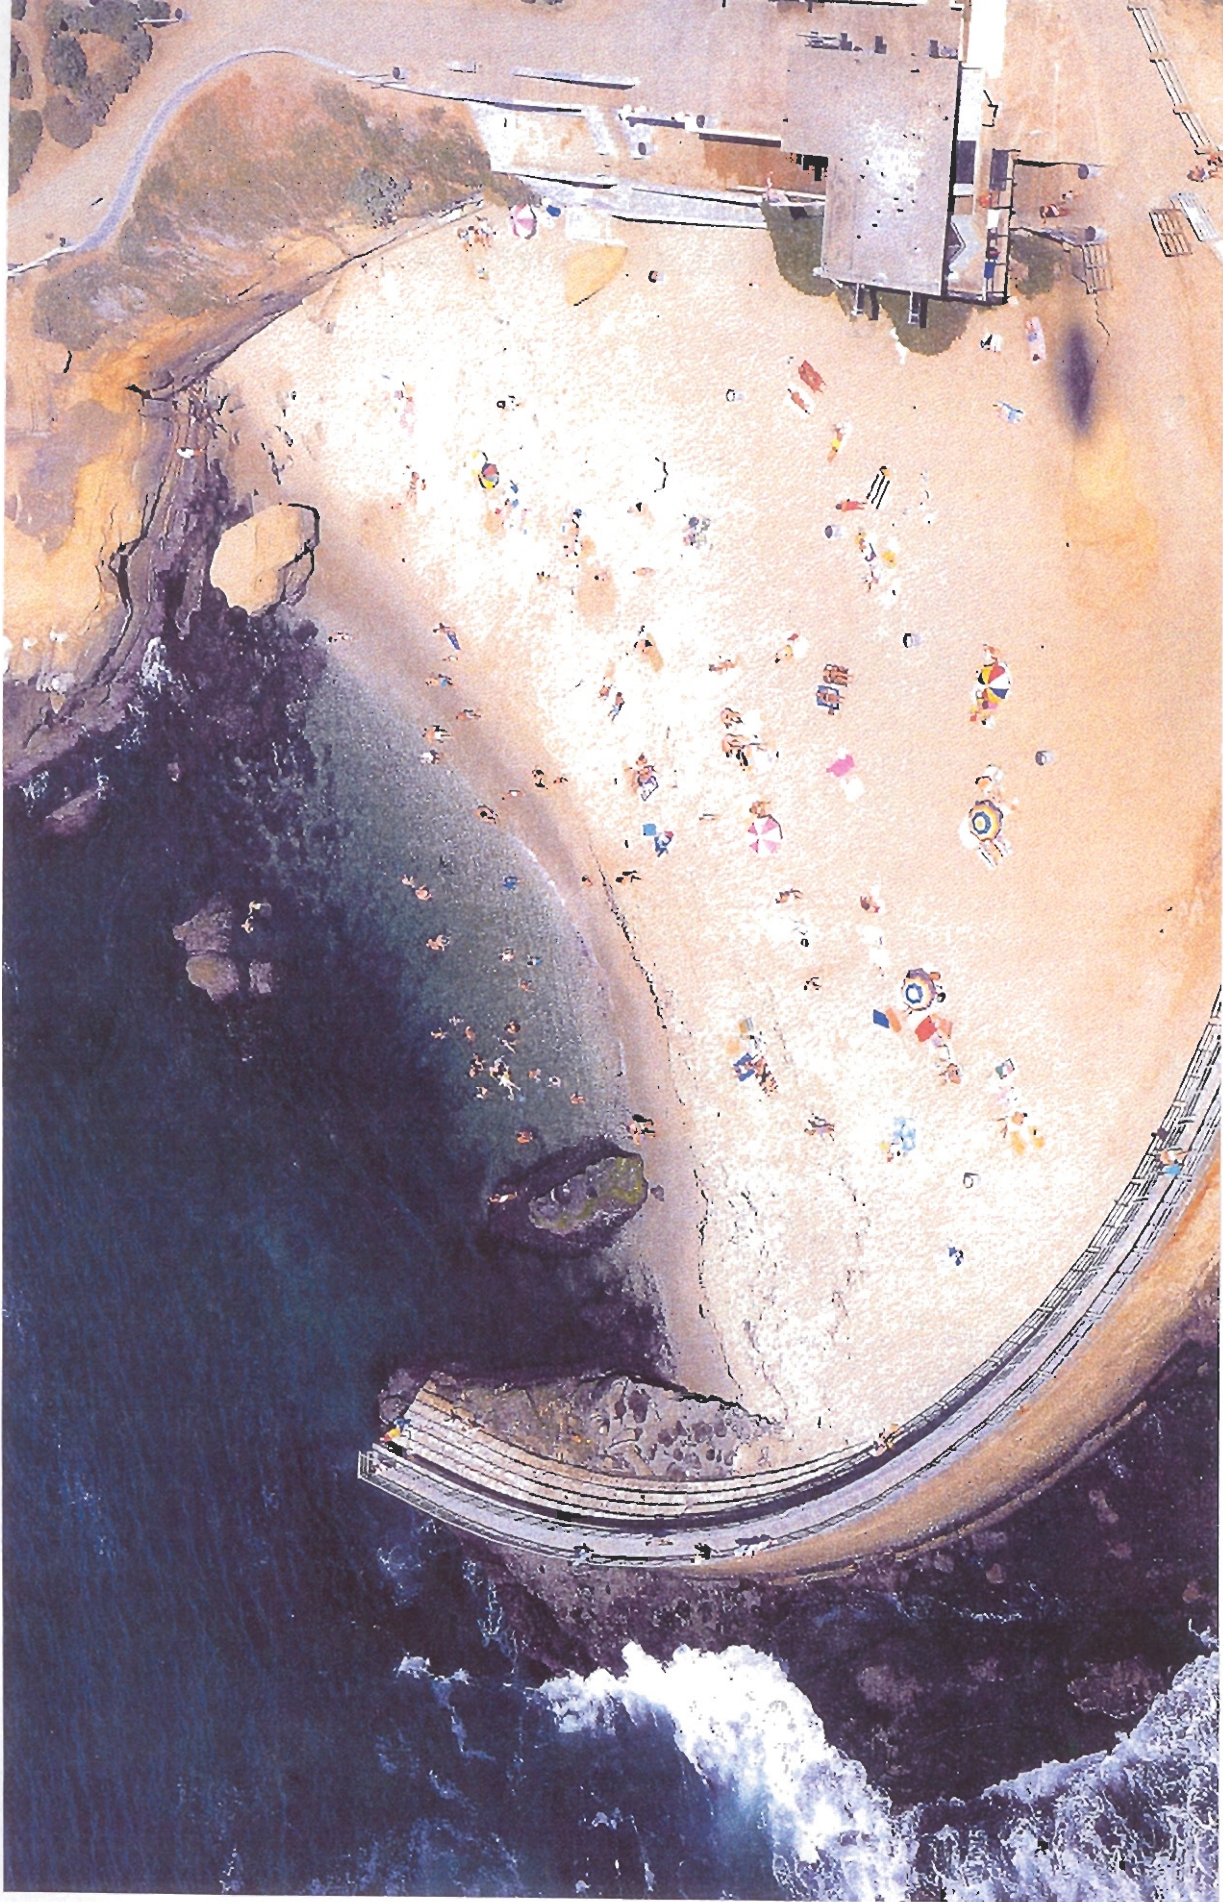
Figure B-8. La Jolla Children's Pool in 1989 (Source Cameron and Morgan, 1990).

twice as wide as the distance from the breakwater root to the sluices. In May 1948 (Figure B-6), and July 1953 (Figure B-7; #UT 8248-15), the beach reached approximately 60% (24 posts) of the breakwater length. A new railing was constructed along the seawall after the old railing was severely damaged by the 1982/83 cluster storms. By about 1989 (Cameron and Morgan, 1990), the beach width was about 75% (50 posts out of about 67 at this time) of the breakwater length (Figure B-8). Finally, by early 1998, the shoreline extended to about 80% (55 posts) of the length of the breakwater (Figure 2).
